# Cohesive and Interfacial Fractures in Particulate Polymer Composites: Reflow-induced Filler Densification and Epoxy-Filler Adhesion Loss

Dexter delos Santos<sup>1</sup>, Amor Zapanta<sup>2</sup>, Ian Harvey Arellano<sup>2</sup>

<sup>1</sup>Failure Analysis Group, <sup>2</sup>Central Engineering & Development  
STMICROELECTRONICS, INC., 9 MOUNTAIN DRIVE, LISP II, CALAMBA 4027 LAGUNA, PHILIPPINES

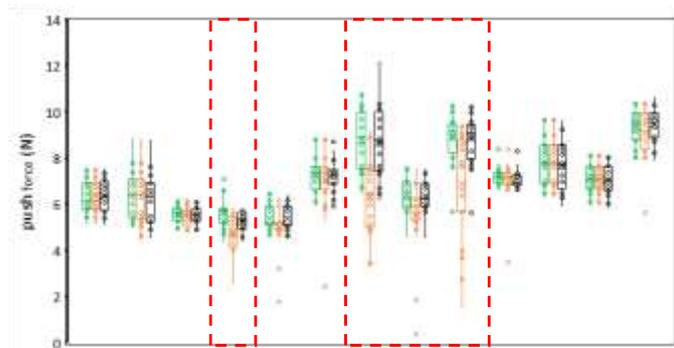
The simultaneous mechanical and electrical testing of the attached surfaces revealed that the integrity of the adhesive joint is limited by the weakness of the S1-CG and S2-CG interfaces. Test results shown in Fig. 2 show that the early joint failure occurs in the CG area (orange data), and the failure occurs only in samples that underwent reflow (red box). This prompted a systematic failure analysis to ascertain the cause of this failure mode.

Fig. 2. Push test results showing early electrical failure in the interfaces created by the CG. Data enclosed in red box are samples that underwent reflow process. The orange bar shows push force where electrical failure is encountered indication fracture within or along the CG region.

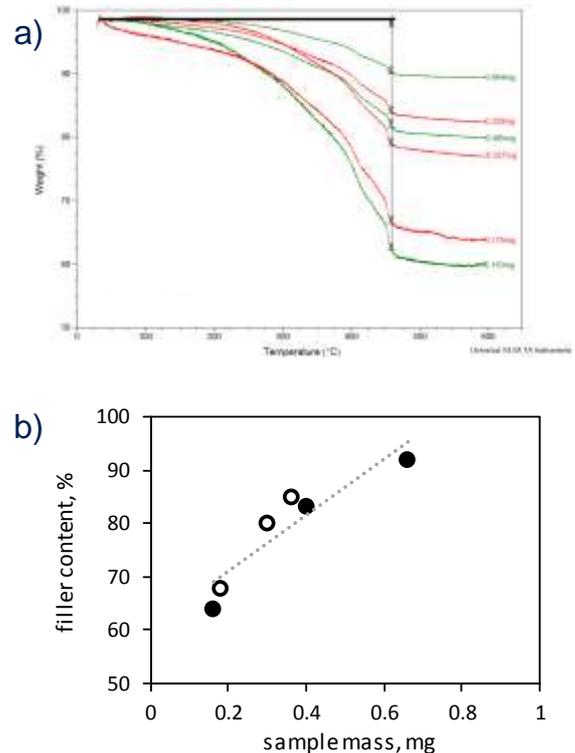
Preliminary analysis considers the glue material as a potential source of the failure, possibly due to excessive outgassing resulting in crack initiation and propagation, or an out of control filler concentration resulting in less epoxy content, and hence weaker adhesion. TGA profiles (Fig. 3) reveals that there is no significant difference in the outgassing behavior and filler content between samples with and without reflow treatment. These results eliminate the possibility of the CG material as the culprit of the observed failure.

Fig. 3. a) TGA profiles of different sample mass for systems with (red) and without (green) reflow. b) Comparative plot of filler content of samples with (●) and without (○) reflow.

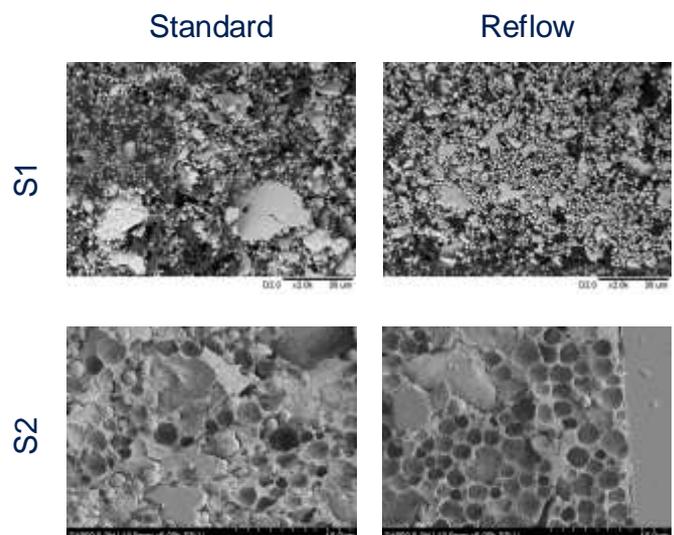
Micrographs of the fractured surface (Fig. 4) after the push test reveal important clues on the mechanism of the failure. The CG has a stronger adhesion with the S1 surface as indicated by the larger volume of the CG remnant on this surface. The fractured surface revealed that the spherical Ag fillers populate the surface. Chunks of smooth surfaces on the fractured surface indicate that interfacial fracture is also present, in addition to the more dominant cohesive fracture [6-7]. The interfacial fracture suggests the failure of the epoxy to develop a robust intercalated polymer network, which acts as the anchor of the glue on the surface of S2. The fractured surface of the reflowed sample is more planar, as compared with the sample without reflow, indicating that crack initiation and propagation is lateral and very close to the interface [8]. The higher density of Ag fillers on the fractured surface for the samples that underwent reflow suggests a possible densification of the fillers near the interface. In contrast, the non-uniform fracture plane in samples without reflow suggests that the fillers are more dispersed in this system, preventing a clean and lateral crack propagation [9]. A closer look on the CG remnants on the S2 clearly show more pronounced imprints of the Ag fillers in samples that underwent reflow.

These imprints are epoxy materials that have weak interaction with the fillers. These results indicate that the reflow process induced severe degradation in the strength of adhesion of the epoxy on the spherical fillers, resulting in the total separation of the epoxy and the filler during crack propagation.

Fig. 4. SEM micrographs of the fractured surface after the push test.

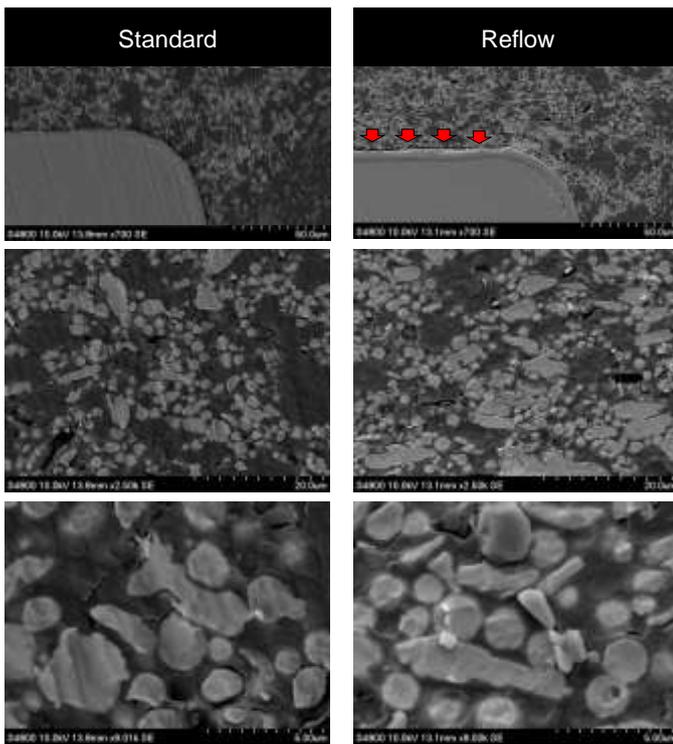
Fig. 5. Cross-sectional SEM micrographs showing higher filler density in the sample that underwent reflow.

Cross section SEM micrographs support the densification observed, revealing that samples that underwent reflow has  $34 \pm 7\%$  higher filler content near the interface as compared with samples without reflow. The higher filler content means that the epoxy content is lower, and hence less material that acts as dispersing medium. In addition, the filler-to-filler contact is higher resulting in weaker resistance to mechanical stress [10-11].

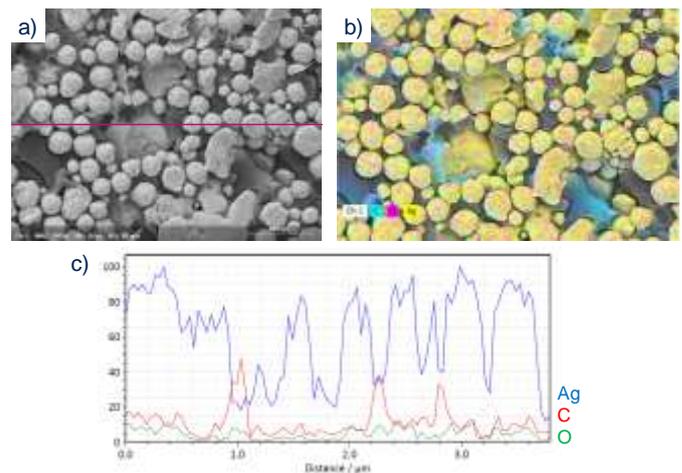
EDS analysis of the fractured surface (Fig. 6) confirmed the propensity of the Ag fillers along the fracture plane. Elemental map and line scan show the low organic content (epoxy) on the fractured surface and the periphery of the Ag fillers. This indicates the adhesion loss between the epoxy and filler as induced by the reflow process.

Fig. 6. EDS analysis of the fractured surface of the sample with reflow. a) Secondary ion image, b) elemental composite map, and c) line scan spectrum (elemental composition taken along the pink line in a).
