# Chip-On-Lead Semiconductor Package with Copper Wirebonding

Antonio R. Sumagpang Jr., Frederick Ray I. Gomez

New Product Introduction Department, Back-End Manufacturing & Technology, STMicroelectronics, Inc., Calamba City, Laguna, Philippines 4027

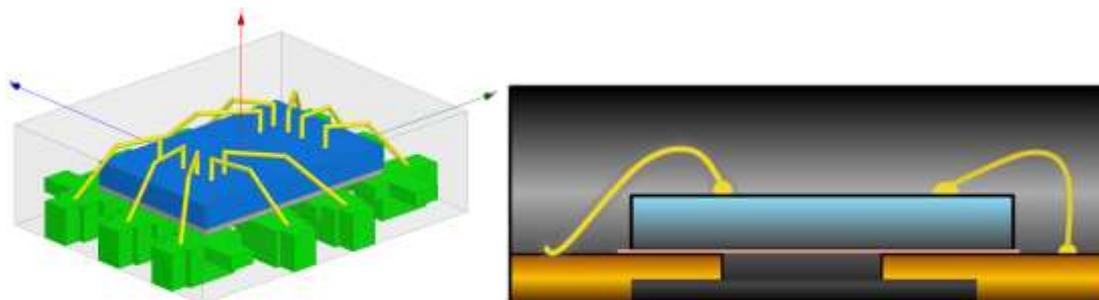
Chip-On-Lead (COL) is a technology where die or crystal is mounted on the leads of the leadframe instead of the paddle. To make it complicated, this leadframe has no tape for support during wirebonding unlike conventional leadframe. COL packages have not only provided a low cost solution on reducing body size requirements, but also have shown proven package robustness meeting target reliability performances and key quality and productivity indices that enabled a production worthy package. Shown in Fig. 1 and Fig. 2 are sample package views and typical molded package outline of COL package, respectively.

Fig. 1. Chip-On-Lead (COL) package sample 3D view and cross-section view.

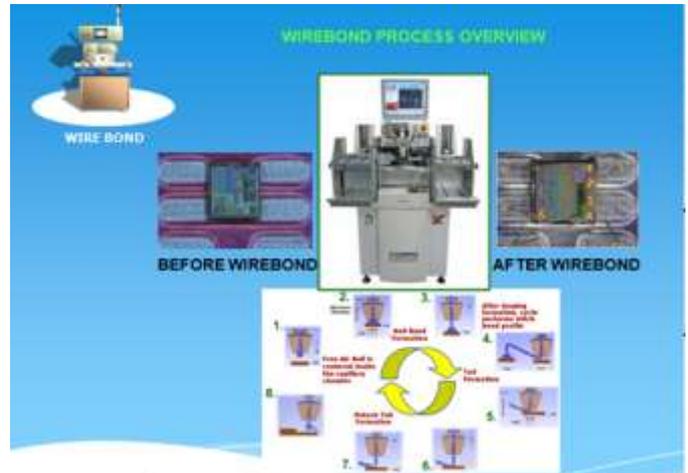
Copper wire and ball bonding is being used for the COL package. Fig. 3 illustrates the overview of the wirebond process. During ball bonding, a ball is first formed by melting the end of the wire (which is held by a bonding tool known as a capillary) through Electronic Flame-Off (EFO). This free-air ball has a diameter ranging from 1.5 to 2.5 times the wire diameter. Free air ball size consistency, controlled by the EFO and the tail length, is critical in good bonding. The free-air ball is then brought into contact with the bond pad. Adequate amounts of pressure, heat, and ultrasonic forces are then applied to the ball for a specific amount of time, forming the initial metallurgical weld between the ball and the bond pad as well as deforming the ball bond itself into its final shape. The wire is then run to the corresponding finger of the leadframe, forming a gradual arc or "loop" between the bond pad and the lead finger. Pressure and ultrasonic forces are applied to the

Fig. 3. Wire bonding process mechanism.

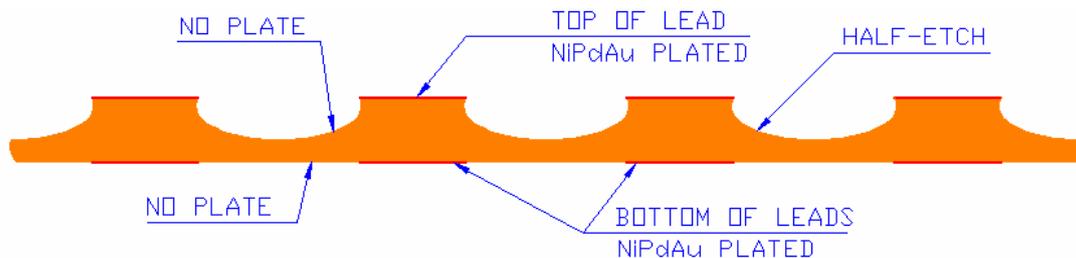
Tapeless Chip-On-Lead package is a leadframe-based package carrier or platform in which the leads footprint will be formed by back-etching process. The plant has a lot to gain with tapeless package – cheaper leadframe cost, Copper wire compatible, no tape and faster sawing speed in singulation. Shown in Fig. 4 is the tapeless leadframe configuration.

Fig. 4. Tapeless leadframe configuration.

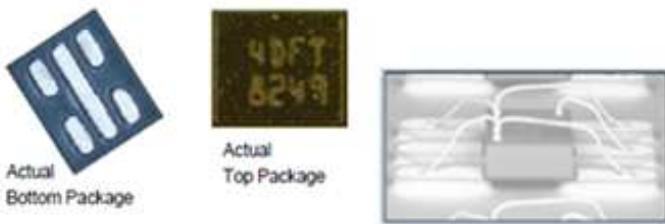
The COL package (hereinafter referred to as Device A) is an Electrically Erasable Programmable Read-Only Memory (EEPROM) device with CMOSF8HP4 die technology and packaged in a tapeless leadframe configuration. The package has only 5 leads or pads or pins. Fig. 5 shows the device configuration.

Fig. 5. Device A configuration.

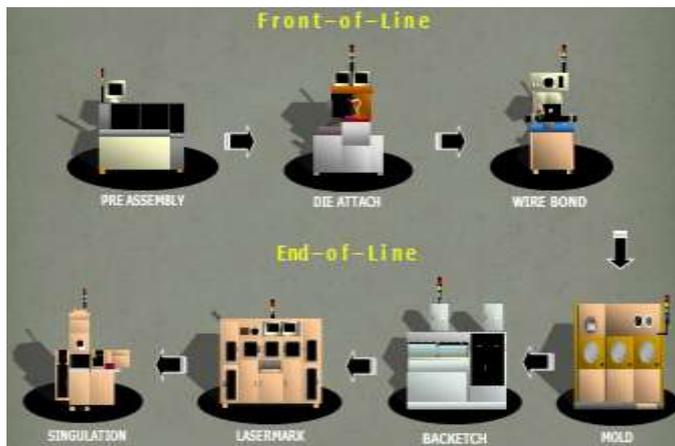
During initial phase of the investigation, all possible variables to determine the yield loss contributors were studied. In the case of Device A, the entire processes were analyzed as this product carries new process bricks and technology for the plant such as Copper wirebonding and the use of tapeless leadframe which is more sensitive than the conventional leadframe. An overview of the assembly process flow is illustrated in Fig. 6. It is worth noting that process flow varies with the product and the technology [7], [8].

Fig. 6. Overview of Device A assembly process flow.

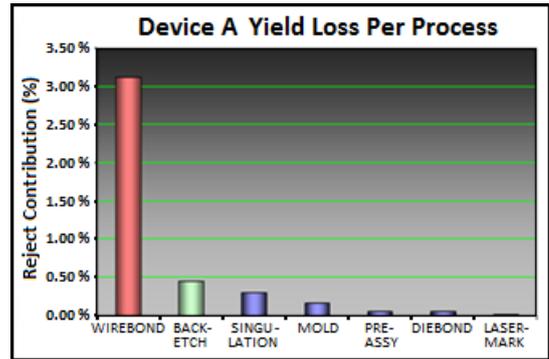
During the investigation, it was established that the major source of yield loss during ramp-up stage is wirebond. This is a substantial finding so that attention and effort for the root-cause analysis will only focus on this process. Furthermore, yield detractors and top defects were also identified by collecting defect signatures that will serve as lead to further investigate and analyze the root-cause of the problems. Pareto diagram in Fig. 7 shows the yield loss contribution per process

Fig. 7. Pareto diagram of yield loss contributor per process.

Wirebond has ~3.0% yield loss and considered as high priority among other assembly processes. Furthermore, Problem Definition Tree was established, a structured step-by-step statistical tool used in the analysis to systematically guide the team and identify the top priority. Shown in Fig. 8 is the Project Definition Tree (PDT) where all factors affecting the Device A low yield were considered and comprehended.

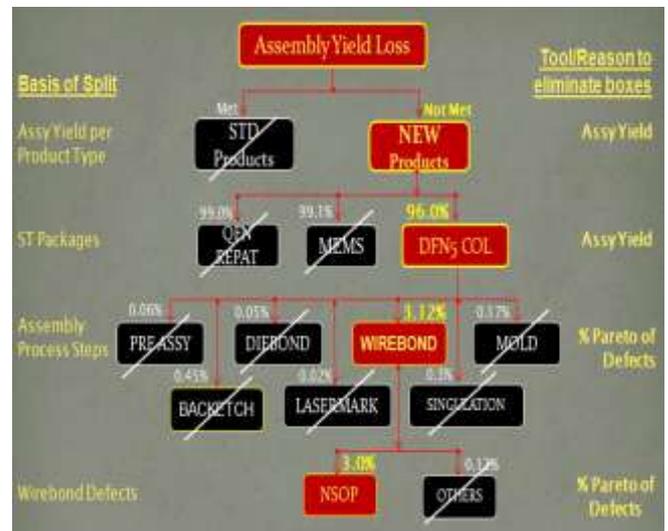
Fig. 8. Problem definition tree.

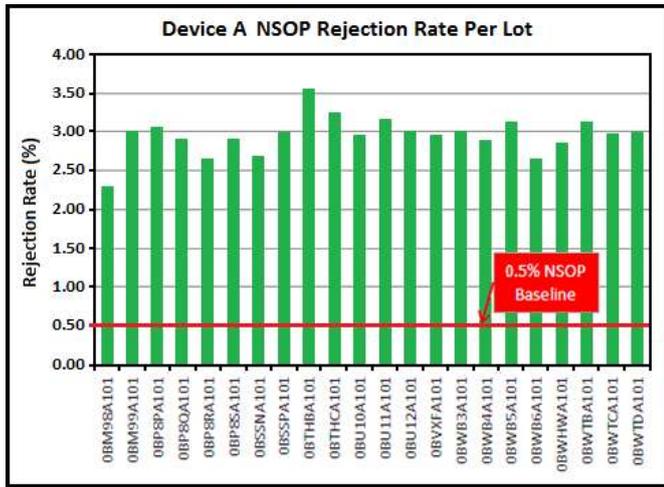
Several lots during ramp-up in production were severely affected and way above the allowable Parts Per Million (PPM) level of 0.5%, as shown in Fig. 10.

Fig. 10. NSOP rejection rate per lot.

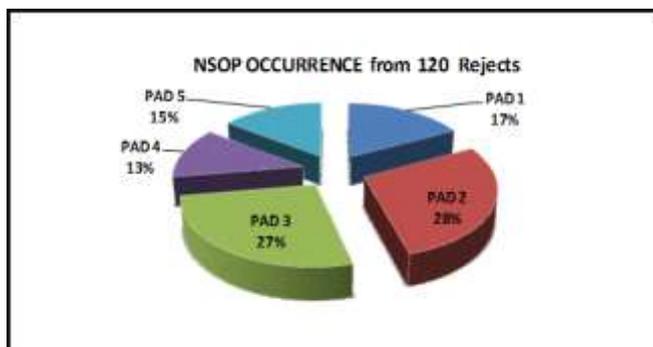
For wirebond process, the top defect contributor is NSOP (3.0%) based on Pareto principle. The 0.12% other defects (trivial many – composed of many small percentage of defects) was not included in the analysis to save time and effort. Shown in Fig. 11 is the NSOP occurrence in 5 pads of Device A.

Fig. 11. NSOP pie chart.

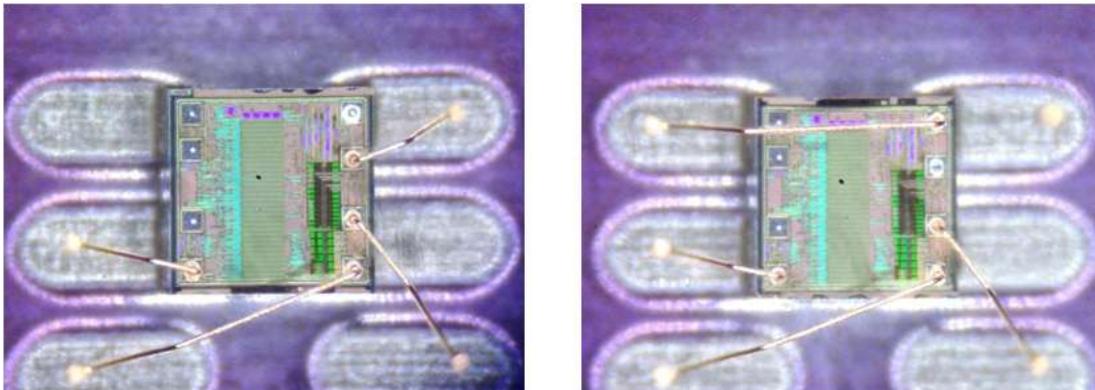
Sample photos of bonded units showing NSOP manifestation on pads 1 and 2 are shown in Fig. 12. Similar manifestation occurred on pads 3, 4, and 5.

Fig. 12. NSOP defect mechanism.

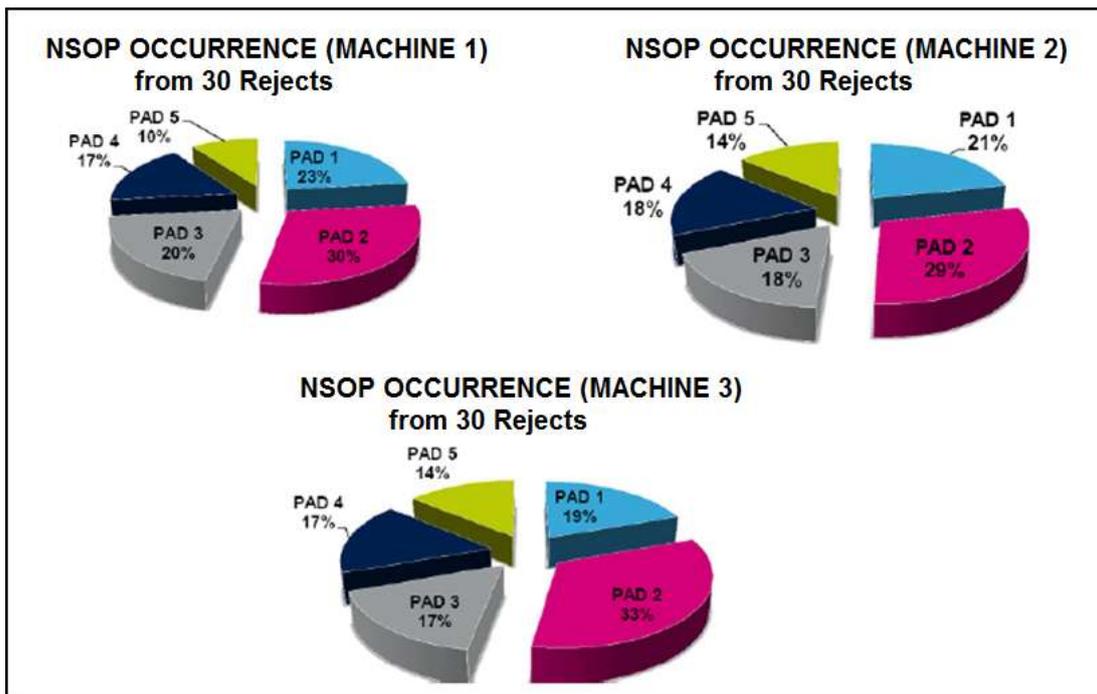
Machine-to-machine validation was also performed to check if NSOP defect is not machine related. The comparison is shown in Fig. 13.

The same diffusion wafer batch was split into three wire bonding machines but gave the same results and level of NSOP rejects. With that, wirebond machine was set aside in the investigation.

Fig. 13. Wire bond machine-to-machine comparison.

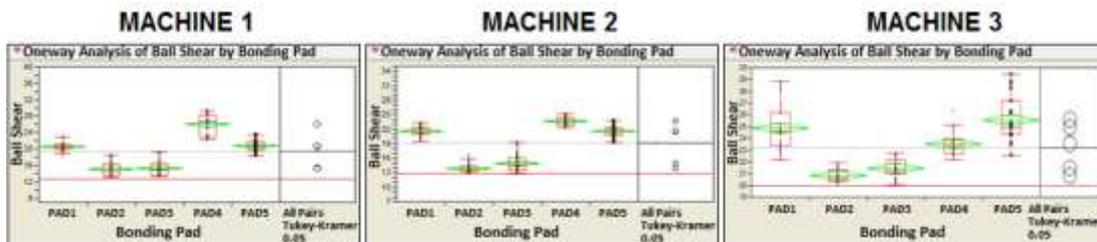
Table I, which was earlier presented, shows the validation made on all wirebond machined being used to process Device A. Significant differences in ball shear results were observed, as eventually illustrated in Fig. 14 using SAS-JMP software [9], a statistical tool that calculates automatically the combination of runs. Readings from pads 2 and 3 are passing but are significantly lower than those of pads 1, 4, and 5.

Fig. 14. Wire bond machines statistical analysis.

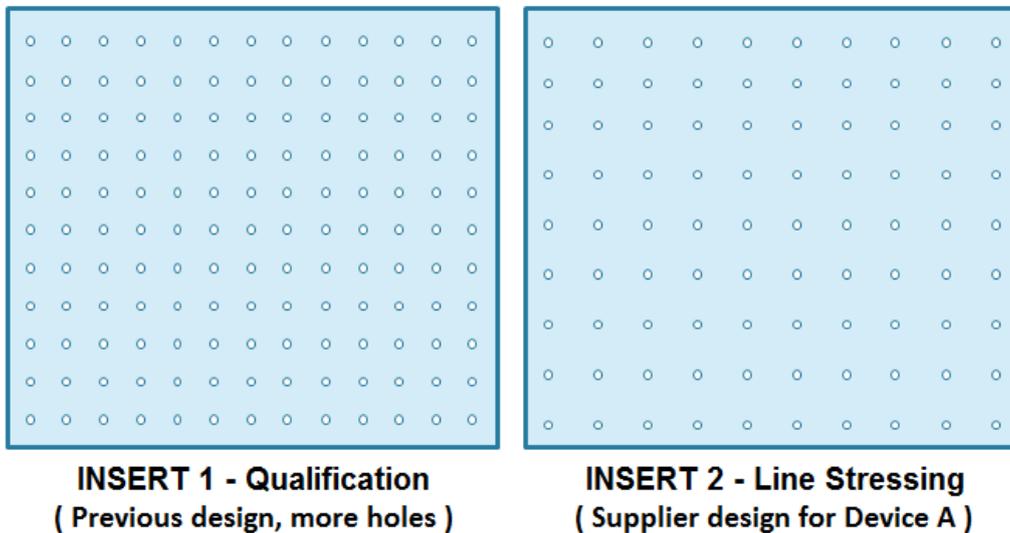
Digging deeper, further validation was made through Why-Why Analysis as exemplified in Table II. This confirms that the “Red-X” is the configuration of the designed insert used during the line stressing lot of Device A, causing the NSOP rejection.

More holes on the insert avoid air traps in between units and eventually flatten the leadframe during vacuum at wire bonding. Fig. 15 compares the old insert design and the new insert design.

A flattened leadframe results to better wire bond quality and less probability of NSOP occurrence. Table III and IV present the Why-Why Analysis of systematic root-cause and escape root-cause, respectively.

Fig. 15. Old and new inserts comparison.

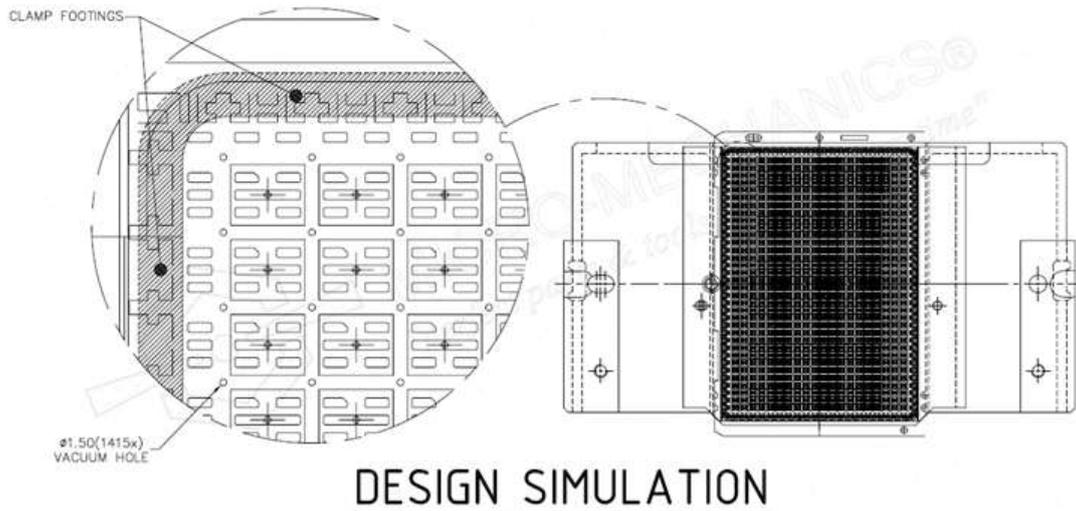
Fig. 16. New design of clamp and inserts.

A Design-of-Experiment (DOE) for 1st bond parameters was conducted with the objective to determine and define window that will minimize occurrence of NSOP. New insert design (Rev 1) shown in Fig. 16 has total of 1,415 holes to

hold 680 units per panel while the original insert design (Rev 0) has only 220 holes.

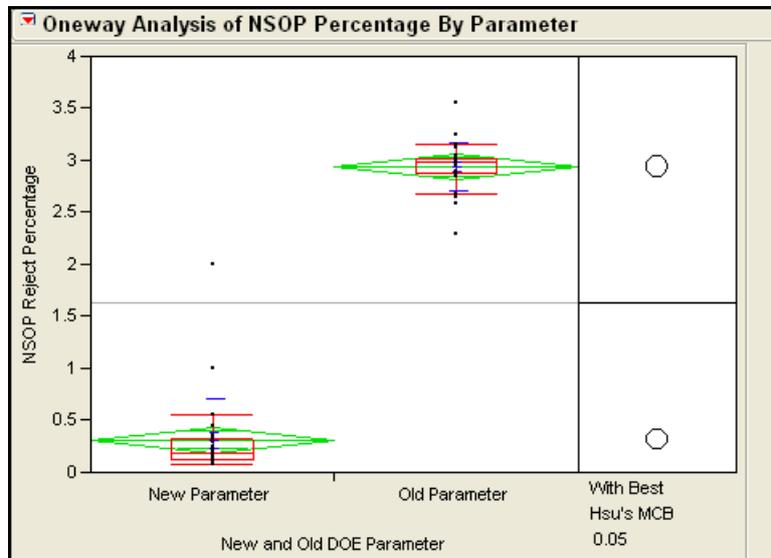
T-Test or Analysis of Variance in Fig. 17 revealed significant difference using new design or parameter over the previous design.

Fig. 17. Statistical analysis graph showing significant difference between parameters on old and new clamp and insert design in terms of NSOP attribute data.

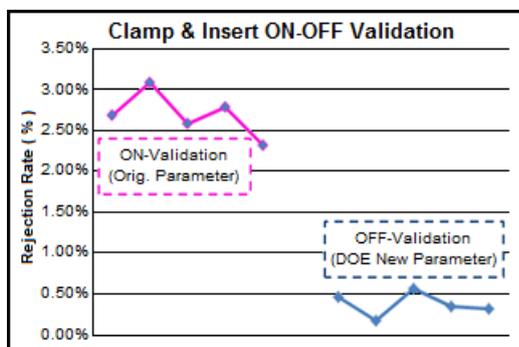
To strengthen the premise on NSOP is due to clamp and insert design. Wirebond parameters were brought back to its original set-up. Employing On-Off validation, it is evident in Fig. 18 that new clamp and insert dictates the outcome of NSOP rejection rate. Results of all experiments and validation runs strengthen the conclusion that the NSOP due to poor design of clamp and insert can be mitigated using higher new design with enhanced vacuum capability.

Fig. 18. Clamp and insert design/parameters On-Off validation.

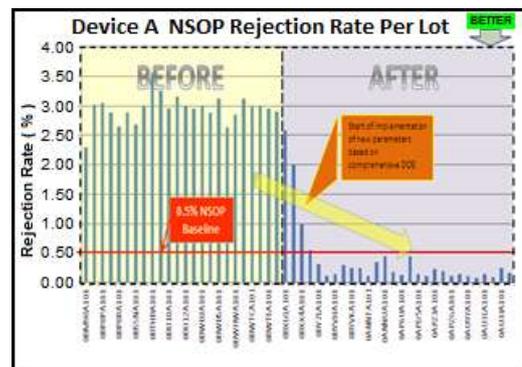
Continuous monitoring on the lots during mass production was carried out. Result of verification, showed that the lot using new clamp and insert design has an average of 0.32% reject rate. NSOP trend together with the action and date of execution was monitored to confirm and validate the

effectiveness of the implemented solution. Shown in Fig. 23 is the detailed monitoring graph regarding NSOP before and after the solution implementation.

Fig. 23. NSOP lot trend before and after the implementation of the corrective actions.

After replacement of new clamp and insert design that mitigates the risk of NSOP defects and validations in terms of Quality and Reliability aspects, large scale evaluations were made through Line Stressing to validate effectiveness of new clamp and insert design. Error proofing was employed to identify actions that will either control or eliminate these errors.

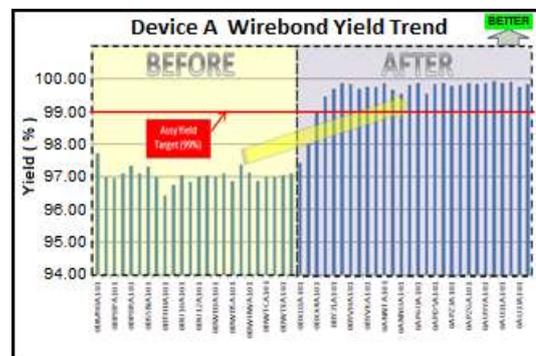
Other factors were also measured particularly scrapping of lots due to high NSOP rejection, and significant effect was felt in the Scrap rate. More importantly, assembly yield was increased by more than 3% and meeting the wirebond yield of 99.5%. Yield trend stabilized after the implementation of corrective action, as shown in Fig. 24.

Fig. 24. Assembly wirebond yield trend.
